**CONDITION AND TREATMENT REPORT**

**DATE:** September 19, 2012

**OBJECT:** One of a group of two donated American custom designed and manufactured armchairs for the Hall of the House of Representatives, currently in the collection of the United States House of Representatives, known as the "Walter" armchairs, after their designer, Thomas U. Walter. The primary wood is American oak; the secondary wood is oak, manufactured by Bembe and Kimbel of New York, circa 1857.

**ACCESSION #:** 331833 (old); 2006.18.2 (new).

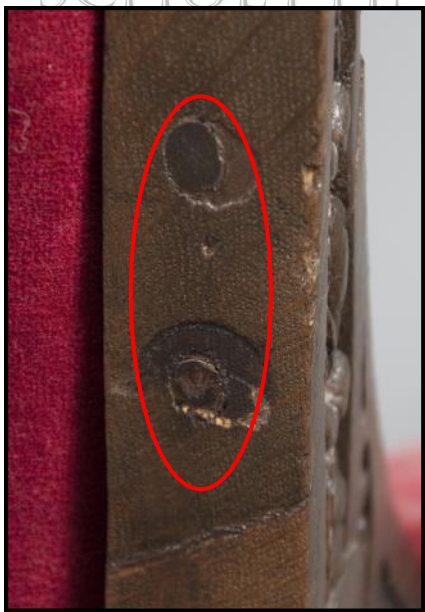
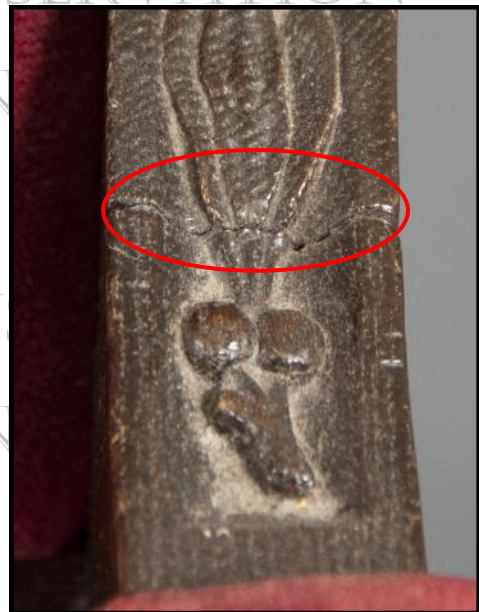
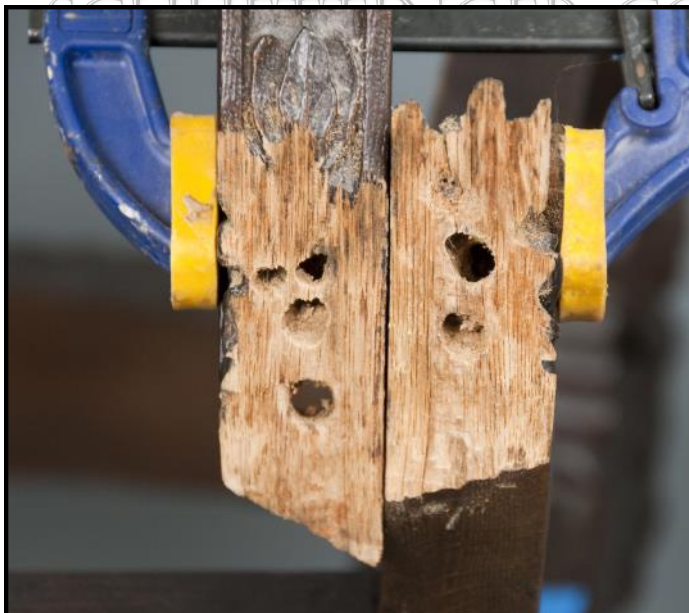
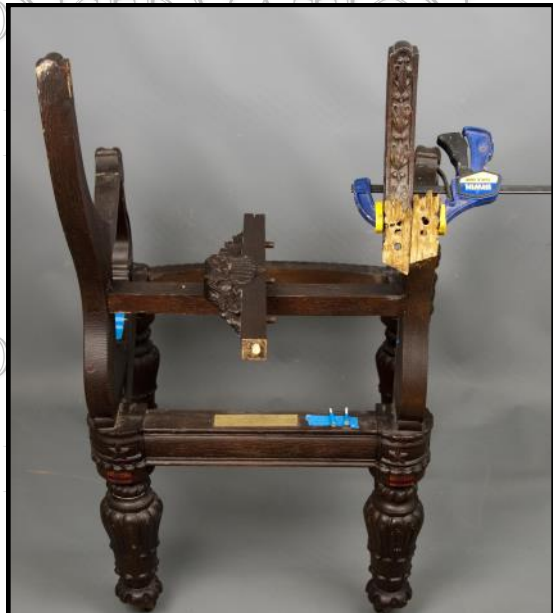
There was a major fracture on the proper left stile of the chair. Previous attempts had been made to secure the fracture, using dowels and glue, but these attempts failed to make the chair structurally sound. The old adhesive and dowels were removed and the dowels discarded.

These images, left and right show the stile before treatment, illustrating the previous attempts at repair. Below left and right show the fractured stile cleaned of the old adhesive and the dowels removed, in preparation for treatment.

To consolidate the previous fracture, Araldite 2015 structural epoxy was used to adhere the fracture, a barrier layer was not used because of the required strength of the joint. A new hard wood dowel was used to fill the holes left from the previous repair regime and was secured with fish glue. Acryloid B-72 20% in toluene was used as a barrier and the area was infilled with Acryloid B-72 color chips applied via a heat system. These areas were incoated with de-waxed blond shellac as a binder, Oresol dyes and ground natural pigments as colorants in a denatured alcohol and de-waxed blonds shellac as the vehicle. Approximately 6 layers were required to achieve the level depicted in the image above right. (see p. 25 for a full coatings treatment).

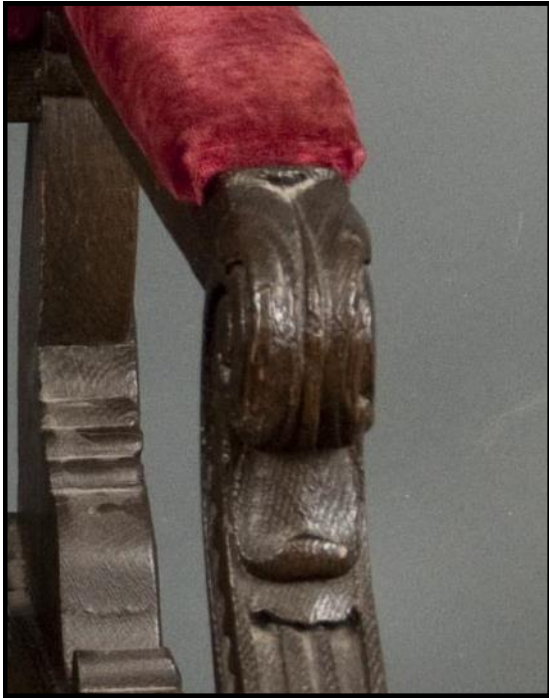
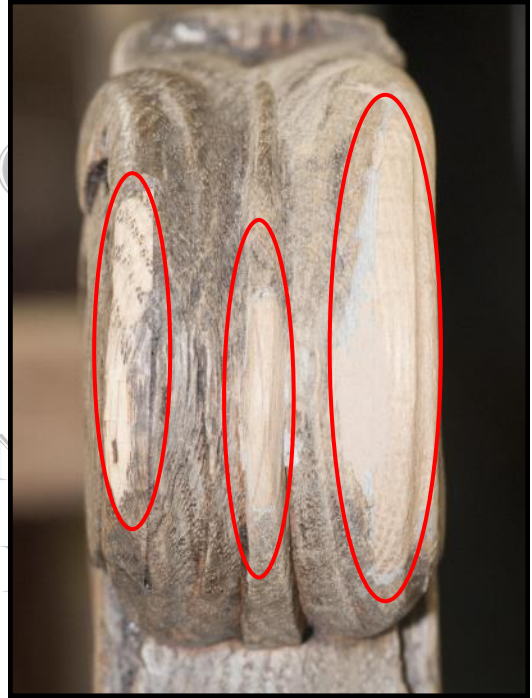
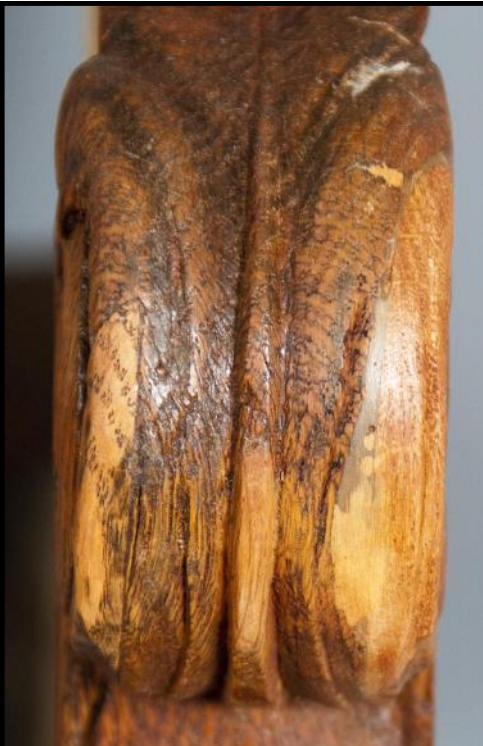
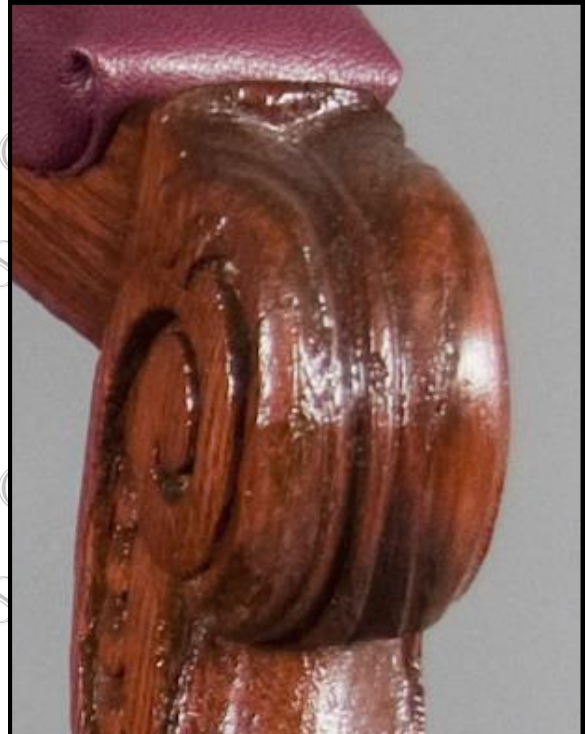
The front facings of the arm terminals also suffered wood losses. These were infilled with wood of like kind and quality. Due to the strength requirements, Araldite 2015 structural epoxy was used to adhere the wood infills. These areas were then coated with de-waxed blond shellac as a binder, Oresol dyes and ground natural pigments as colorants in a denatured alcohol vehicle, followed by dewaxed blonde shellac and the colorants as required for visual integration. (See p. 25 for a full coatings treatment).

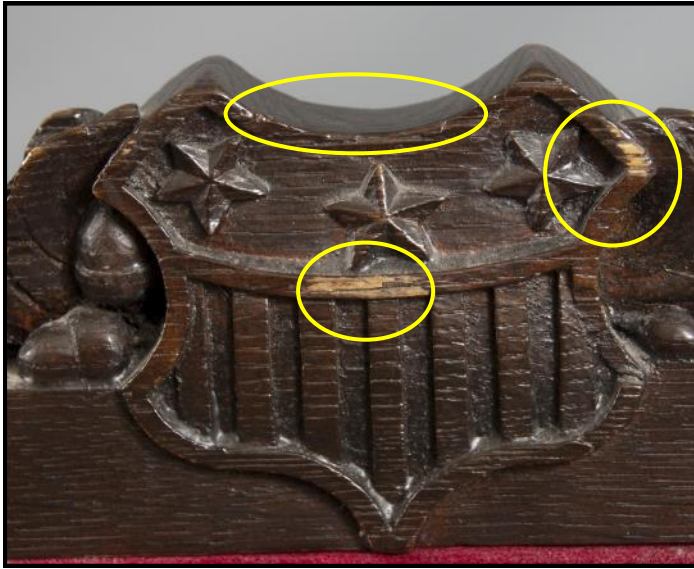
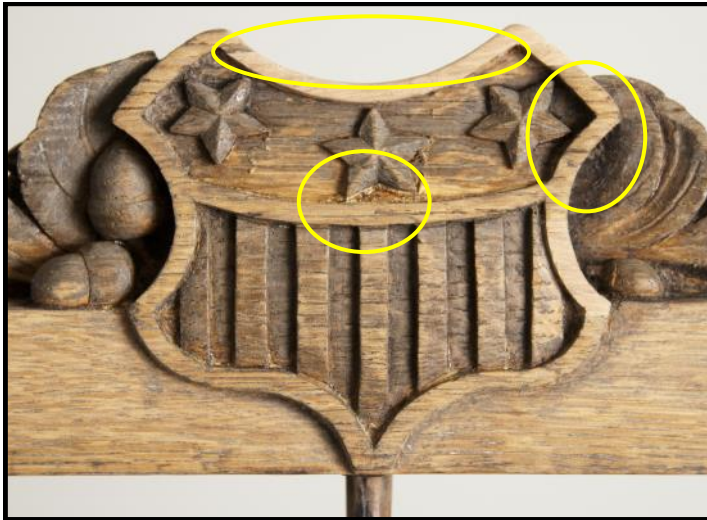
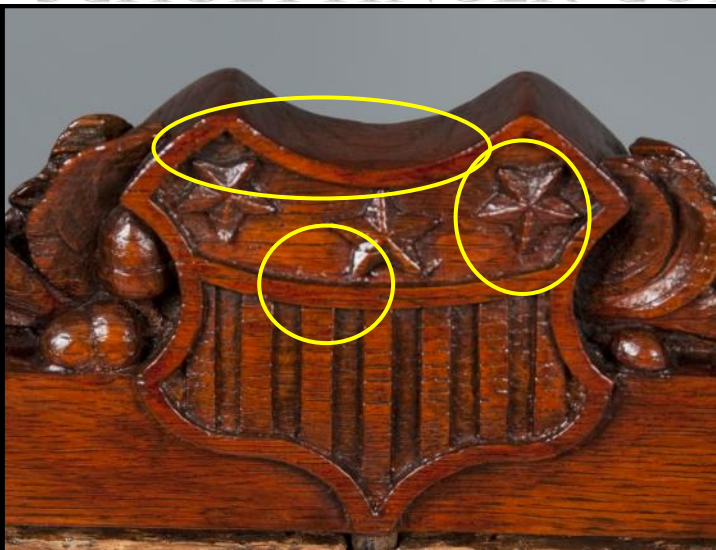
ONLY  
There were minor areas of wood loss to the carved shield on the back of the crest rail, as well as areas of complete coating loss.

NSERVATION  
NC.  
The wood loss was infilled with wood of like kind and quality. Due to the strength requirements, Araldite 2015 structural epoxy was used to adhere the wood infills.

NSERVATION  
NC.  
These areas were in coated with de-waxed blond shellac as a binder, Oresol dyes and ground natural pigments as colorants in a denatured alcohol vehicle. (See p. 25 for a full coatings treatment).

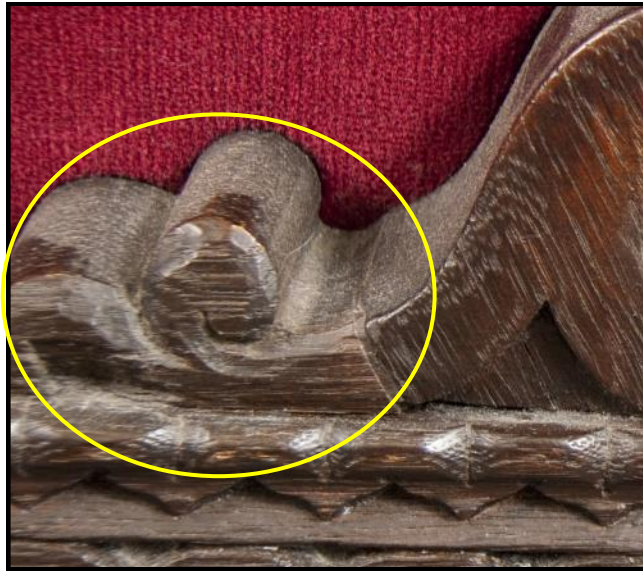
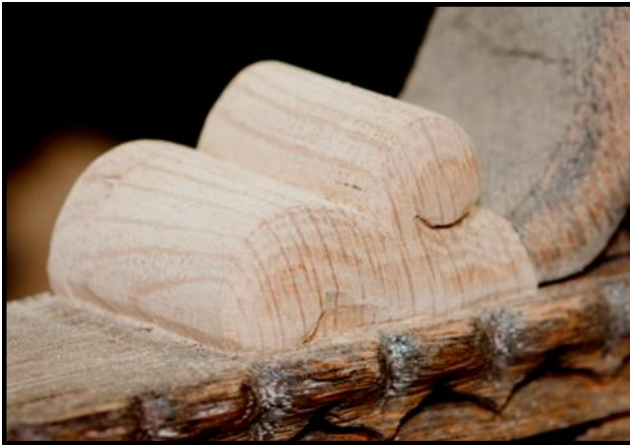
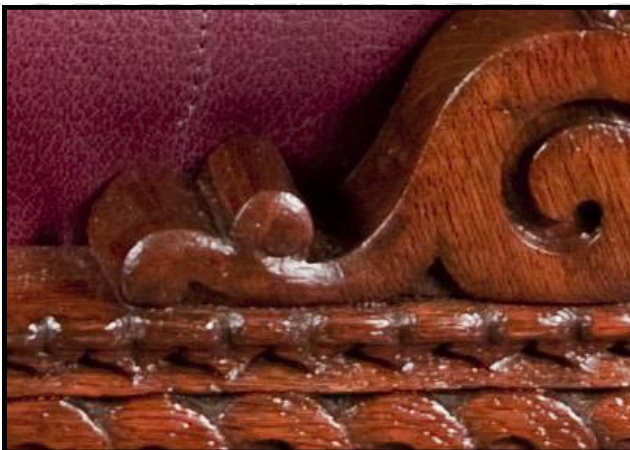
There was a poor previous attempt to replace the wood loss of a carved element on the area where the proper left stile meets the seat rail.

The previous poorly executed wood in-fill replacement was removed and discarded. A new carved element was fabricated of wood of like kind and quality and adhered with fish glue. The existing carved wood in-fill could not be retained and re-carved because its size and proportions were insufficient.

This area was incoated with de-waxed blond shellac as a binder, Oresol dyes and ground natural pigments as colorants in a denatured alcohol vehicle followed by de-waxed blonde shellac tinted with the above mentioned colorants as need for visual integration. This regime was utilized as both an initial staining layer and subsequent tinting layers. (See p. 25 for a full coatings treatment).

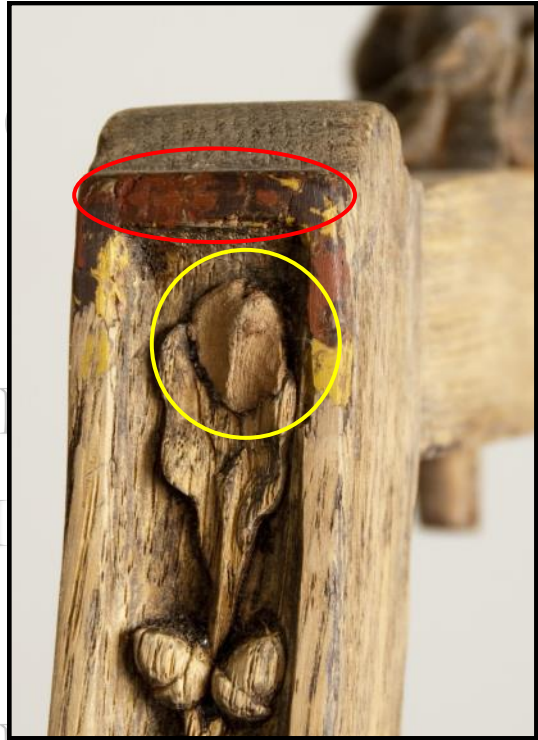
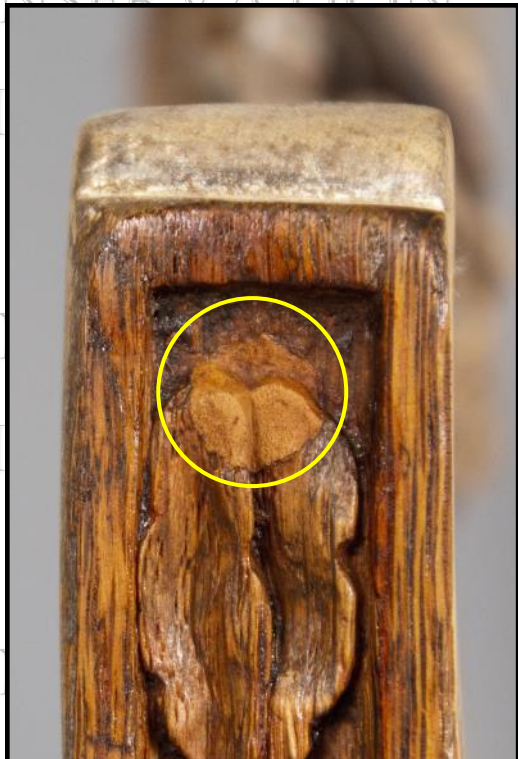
During a previous repair regime, a dowel was used to secure the joint between the stile and crest rail. The joint remained weak. The joint was disassembled, and the dowel discarded and the areas cleaned of old adhesives. A new, smaller dowel was used as a replacement and adhered with fish glue. Due to the loss to the carving, Araldite 1253 structural epoxy was applied to the area of wood loss and carved to match the surrounding surfaces, (yellow circle).

The wood losses on the outside face of the stile were infilled with Acryloid B-72 color chips with a barrier of Acryloid B-72 20% in toluene applied via a heat system (red circle).

These areas were incoated with de-waxed blond shellac as a binder, Oresol dyes and ground natural pigments as colorants in a denatured alcohol vehicle followed by de-waxed blonde shellac tinted with the above mentioned colorants as need for visual integration. (See p. 25 for a full coatings treatment).

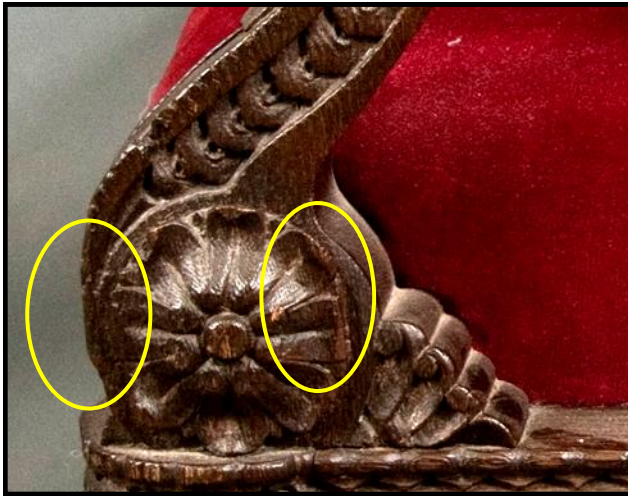
This image illustrates the area of the proper left arm rail where it meets the seat, before treatment. There were areas of wood loss to both sides of the carved floral element

New elements of wood of like kind and quality were fabricated and shaped to fit the existing areas of loss and secured with Araldite 2015 structural epoxy and a fish glue barrier.

These areas were incoated with de-waxed blond shellac as a binder, Oresol dyes and ground natural pigments as colorants in a denatured alcohol vehicle followed by de-waxed blonde shellac tinted with the above mentioned colorants as need for visual integration. (See p. 25 for a full coatings treatment).

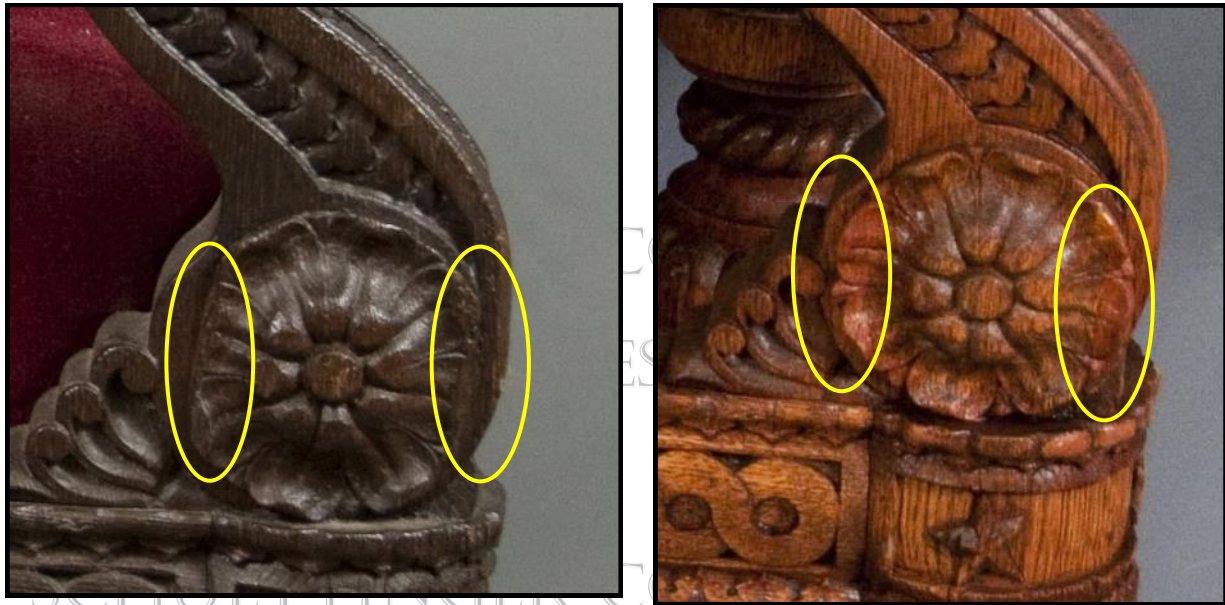
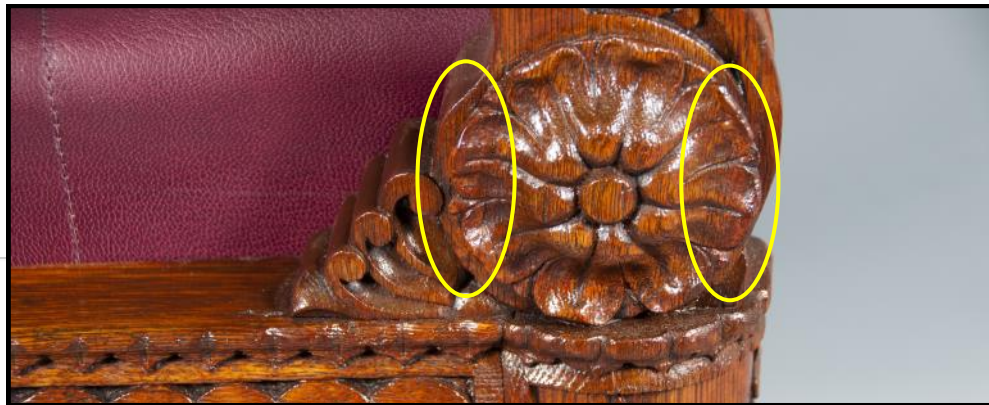
Above left: Area of the proper right arm rail where it meets the seat before treatment. There were areas of wood loss to both sides of the carved floral element.

Above right: Areas of loss were infilled with wood of like kind and quality to the original. The areas were shaped to fit the existing area of loss and secured with Araldite 2015 structural epoxy. Below: These areas were incoated with de-waxed blond shellac as a binder, Oresol dyes and ground natural pigments as colorants in a denatured alcohol vehicle followed by de-waxed blonde shellac tinted with the above mentioned colorants as need for visual integration. (See p. 25 for a full coatings treatment).

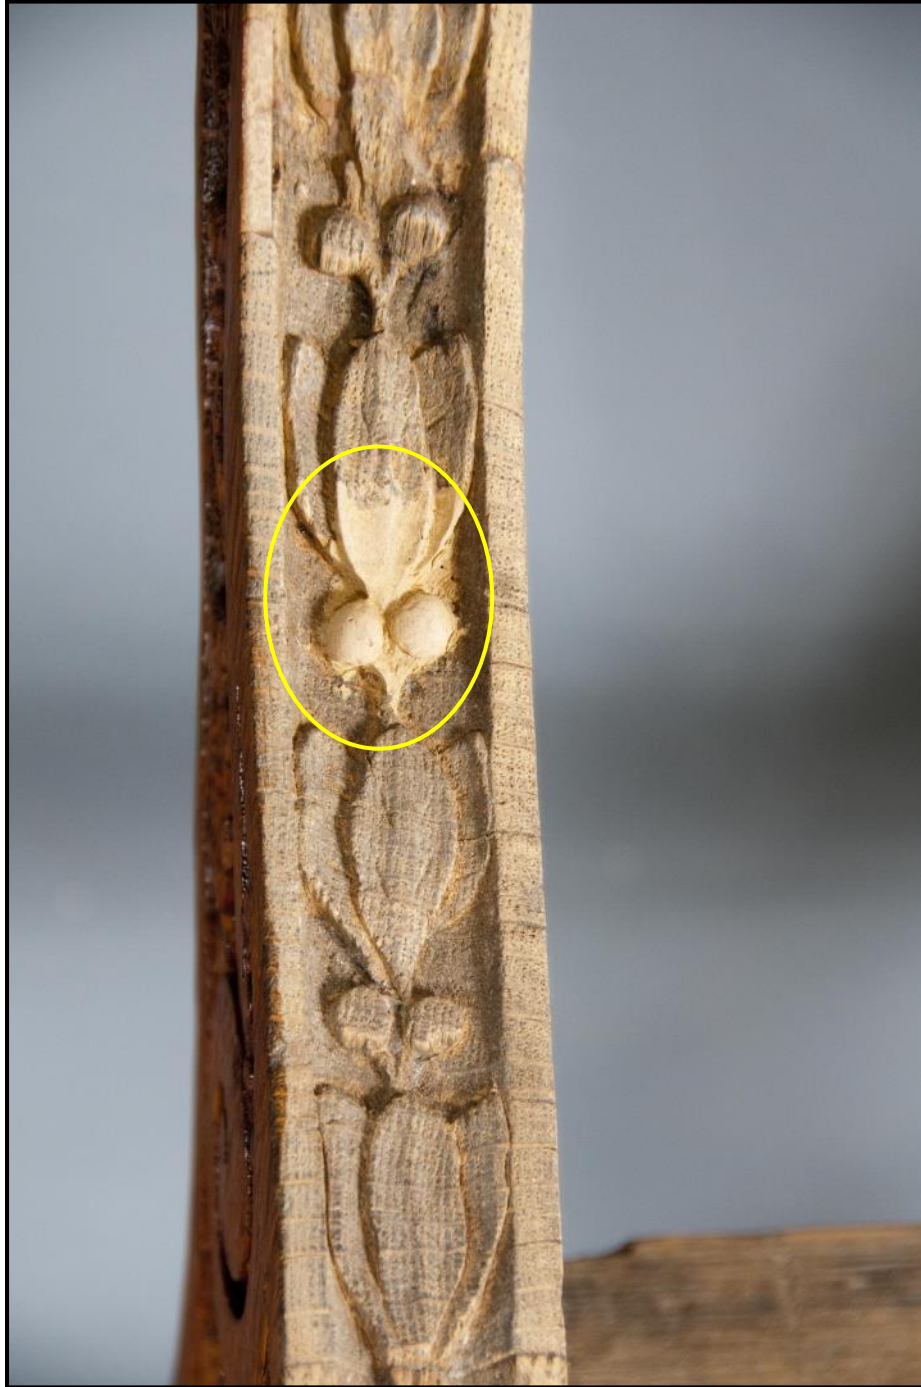
There were areas of loss to carved elements on the stiles of the chair. Araldite 1253 structural epoxy was applied in the area of wood loss, and carved to match the surrounding surfaces. These areas were in-coated with de-waxed blond shellac as a binder, Ore-sol dyes and ground natural pigments as colorants in a denatured alcohol vehicle followed by de-waxed blonde shellac tinted with the above mentioned colorants as need for visual integration. (See p. 25 for a full coatings treatment).

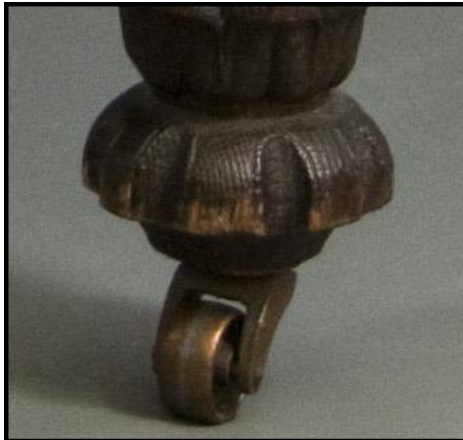
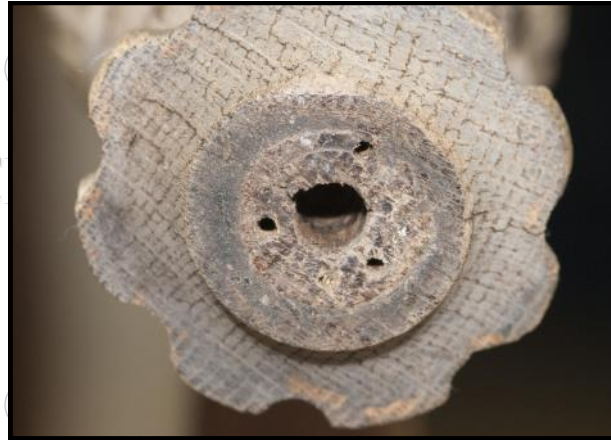
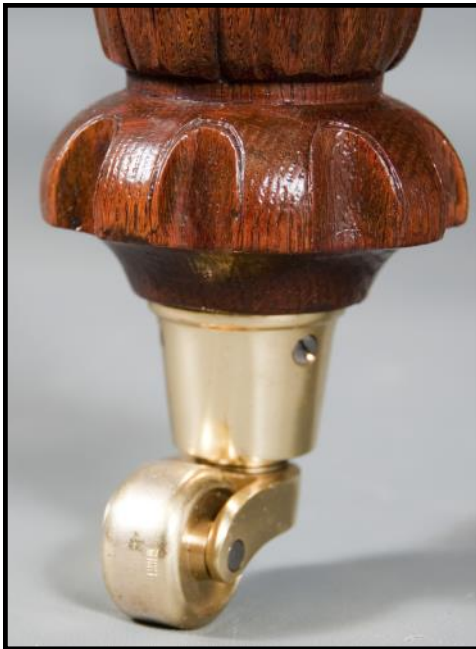
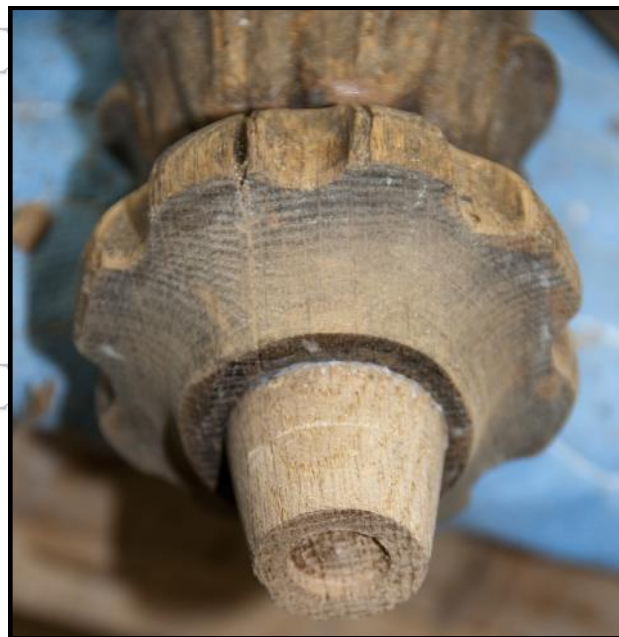
The lower portion of the four original legs to which the original cup form casters were secured were cut in an early repair regime, probably first half of the 20th century. The existing non-original plate caster, which was not a historically correct form of caster, was removed and returned to the US House of Representatives upon completion of the treatment. A new wooden infill was turned to match the original profile of the reproduction cup and to fit into an existing hole in the bottom of each leg. The wood infills that included a turned wooden tenon were then secured to the enlarged existing hole with fish glue and Araldite 2015 structural epoxy where needed.

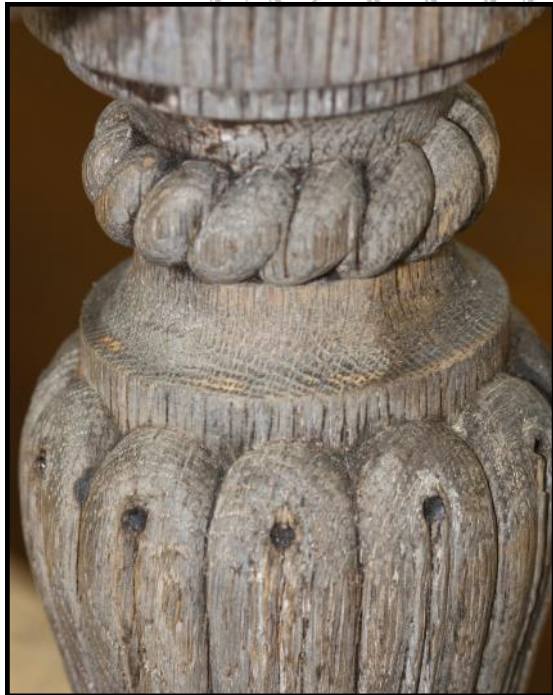
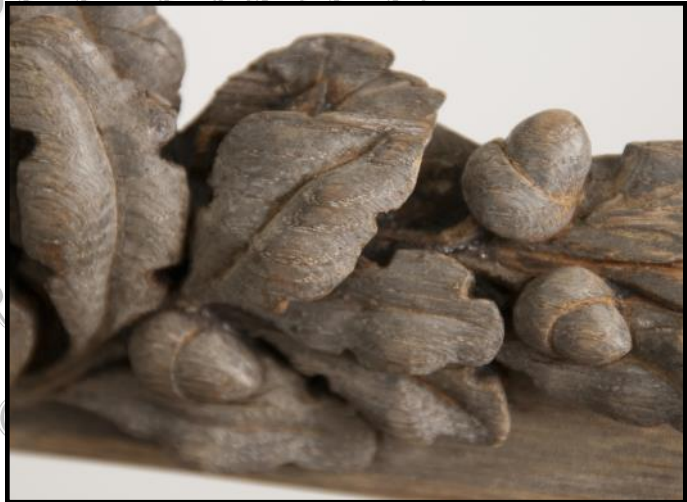
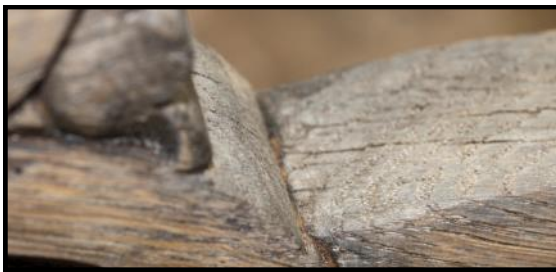
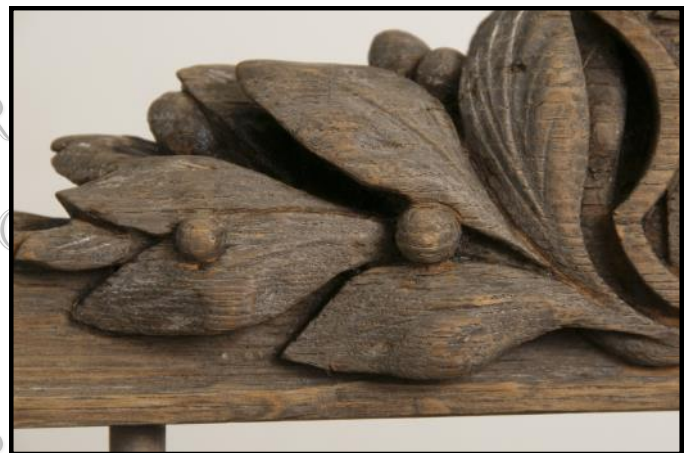
The coating analysis from Richard Wolbers indicated that the existing coatings for the chair covered in this report were an oil based staining layer with a carbon black colorant (see Appendix 1) and a synthetic varnish. However, based on the analysis of other chairs and desks from the larger Walter designed group which originally contained a reddish brown colorant, it is likely that the carbon black residue found in the sample was not associated with the coatings on the chair, but may have been residue from the coating removal regime undertaken on these chairs at the time of their donation in 1968 or were part of a heavily pigmented dark brown stain used to conceal the grey wood from the lye based stripper used in the coating removal process.

This caustic coating removal regime left no material from the original coating layers present. The chair was likely dipped in a caustic stripping agent like sodium hydroxide or a heated lye solution. The existing coatings are composed of a dark synthetic overvarnish poorly applied to the wood show surfaces embedding significant amounts of particulate in the crevices of the carvings. This varnish was probably applied by the Capitol Cabinet Shop.

These images above illustrate the greyish color of the wooden elements of the chair after the existing coating had been removed with the methylene chloride solution. The grey color of the wood surfaces as a result of the stripping would have been a reason for the application of a dark pigmented opaque staining layer indicated in Richard Wolbers report indicating a first generation. It would also explain why the dark pigmented staining layers appears integrated with the wood pores.

This overvarnish was removed with a commercially available methylene chloride with a methylcellulose gel, followed by a denatured alcohol wash. A pH test was performed at that point for a base reading.

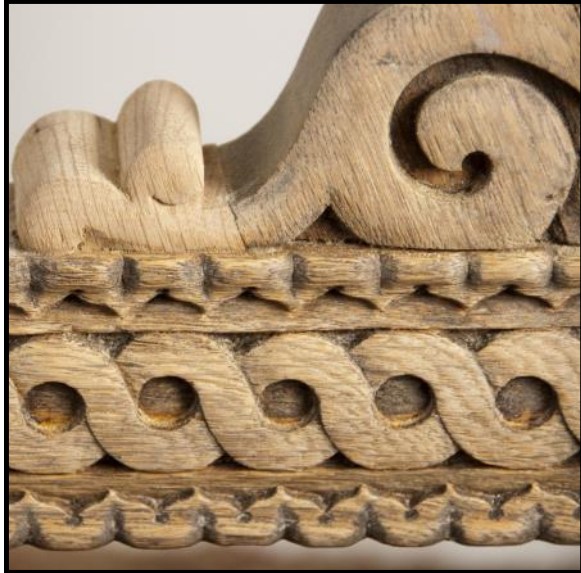
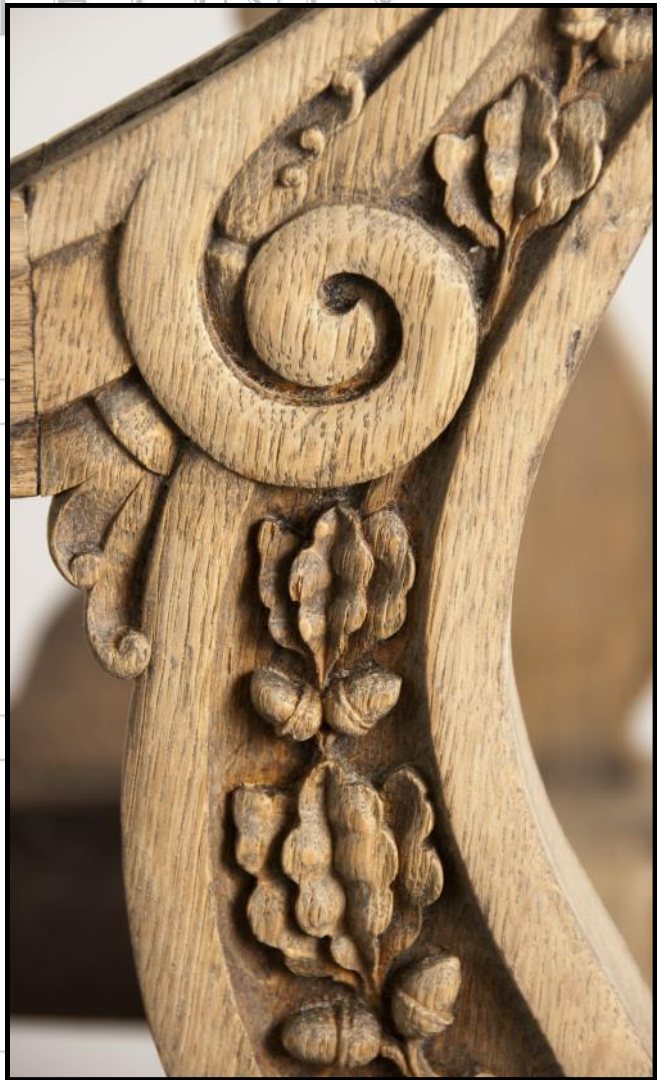
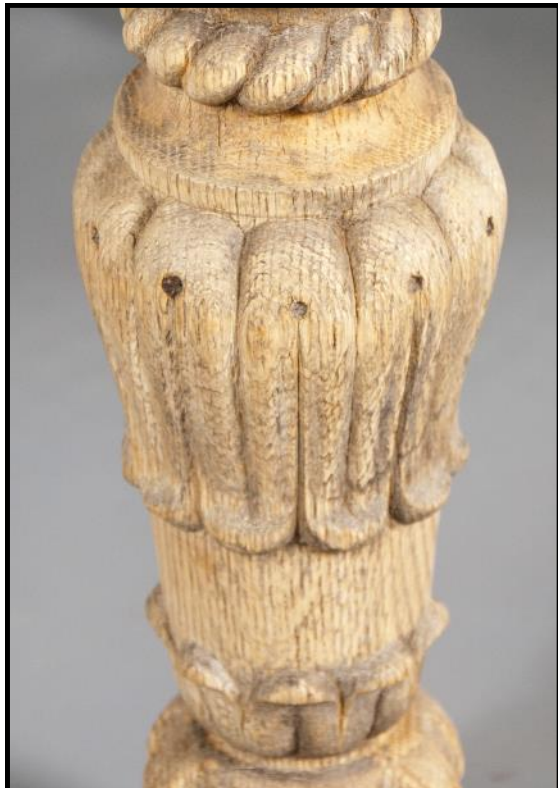
These images illustrate different areas of the chair after the application of the oxalic acid solution and the clear water rinses applied to remove the silver-greyish color remaining from the ca. 1968 coating removal regime.

The wood was then treated with an oxalic acid solution in water with a pH of 3.5% , thickened to form a gel and applied with a brush where the silver greying of the wood was present. Two to four applications of this solution were applied. A pH test of the wood surface was performed where the bleaching solution was applied. These areas were neutralized with two clear water rinses and a buffer solution with a pH of 10.5%. This was followed by two clear water rinses and a dry towel wipe. The final pH test resulted in a pH of 6.8 to 8%.

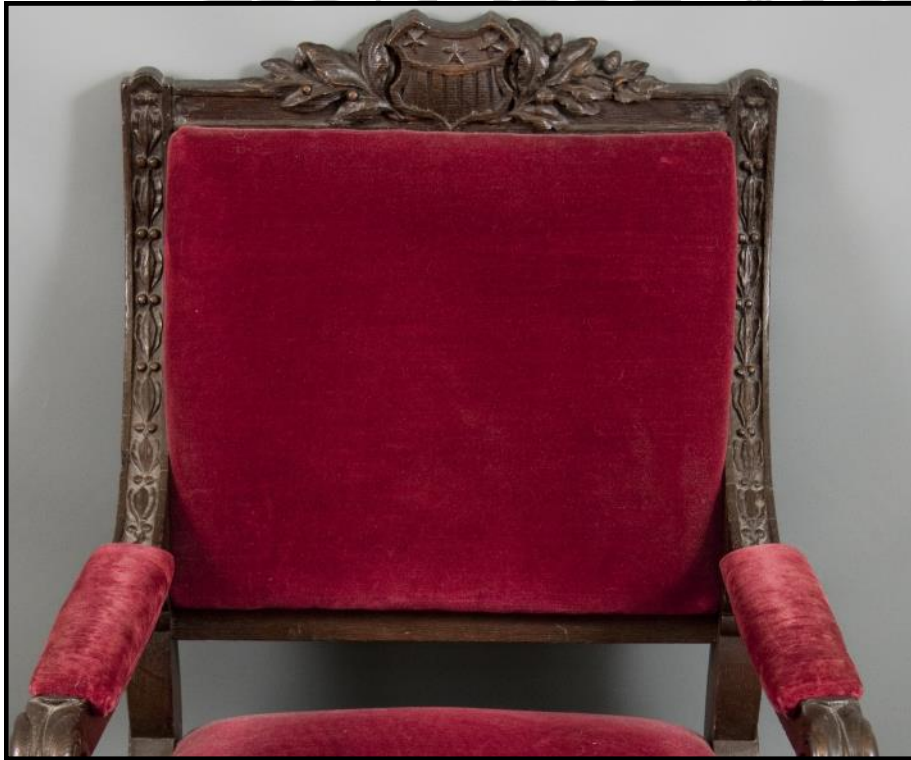
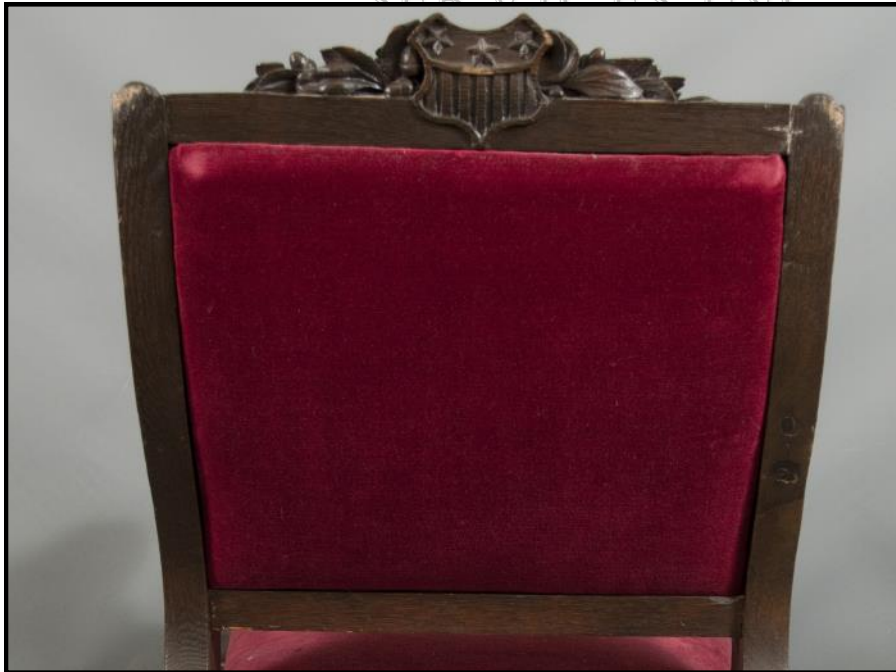
These two images display the non-original reddish brown toned woven fabric on the chair prior to our treatment. Samples of the fabric and the gimp are contained in labeled poly bags supplied with the treatment report. This show fabric appears to be the third or fourth generation of upholstery.

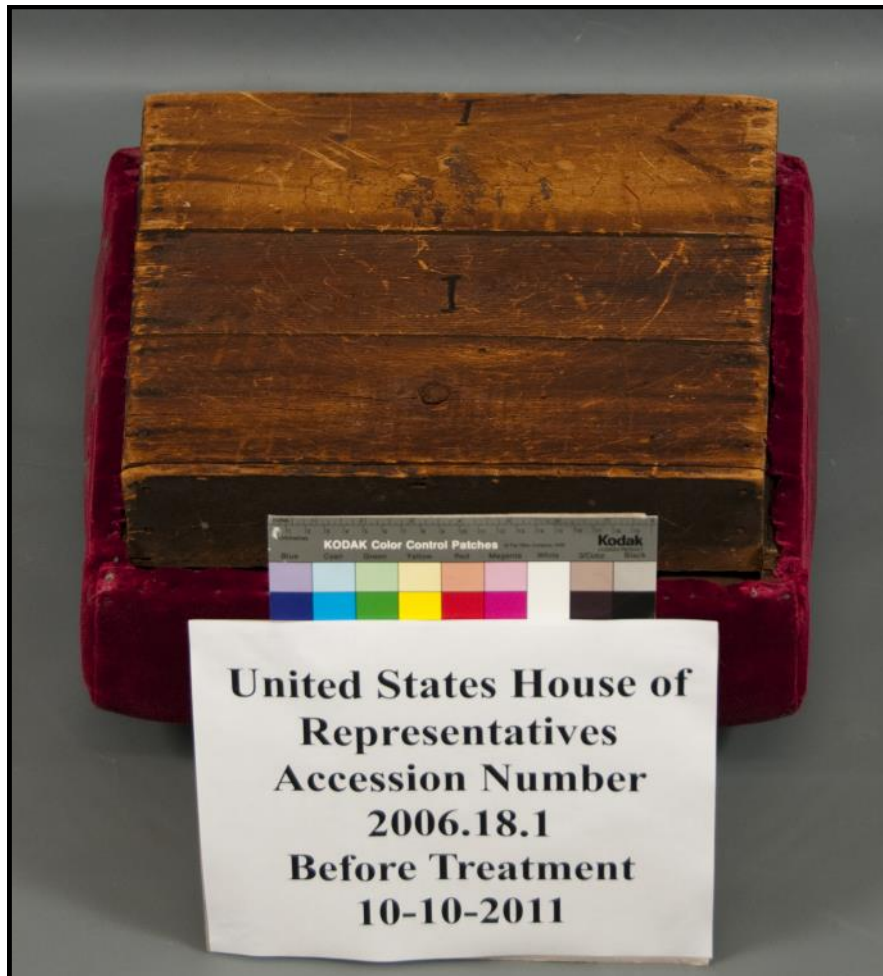
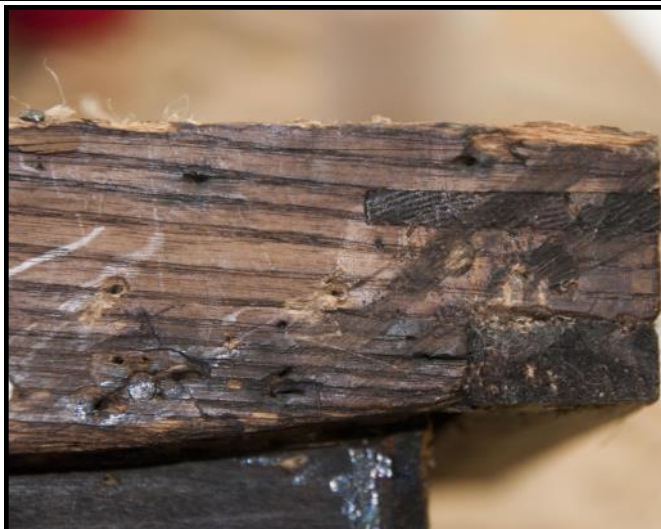
This "winter seat" (as opposed to the summer cane seat) is probably from another chair manufactured by Bembe and Kimbel in 1857. The width of this seat frame was increased with the addition of a strip of wood on the proper right side to improve the fit of the seat frame into this chair. The seat frame is composed of 4 shaped oak rails joined at the corner with a visible mortise and tenon joint (see below left). The frame rails were notched 1/2" to be recessed into the chair seat frame (below right).

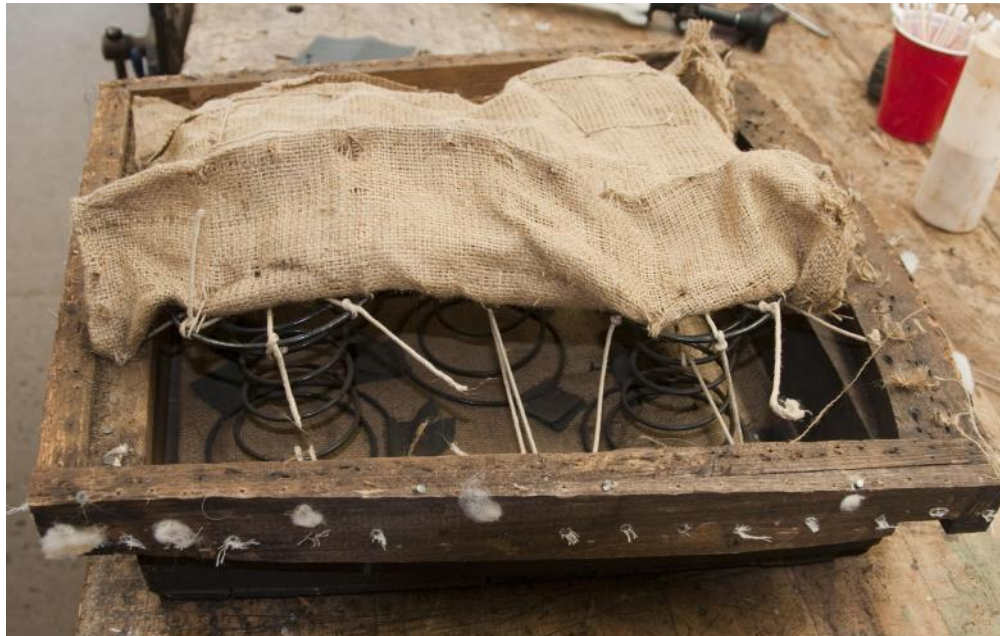
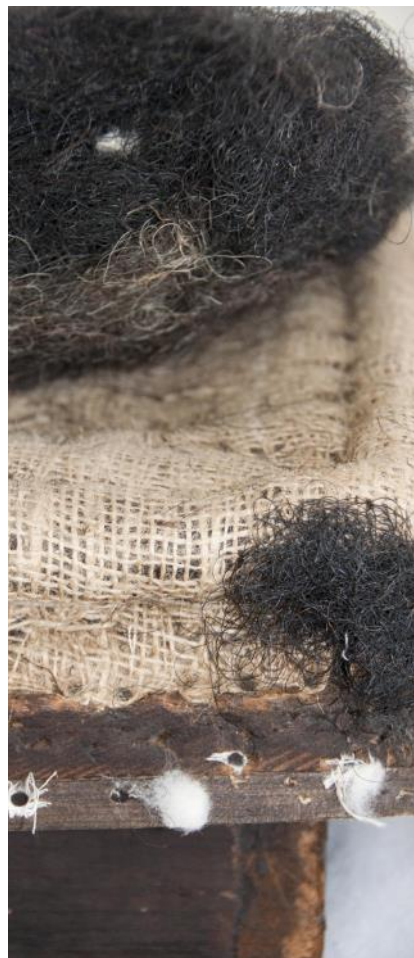
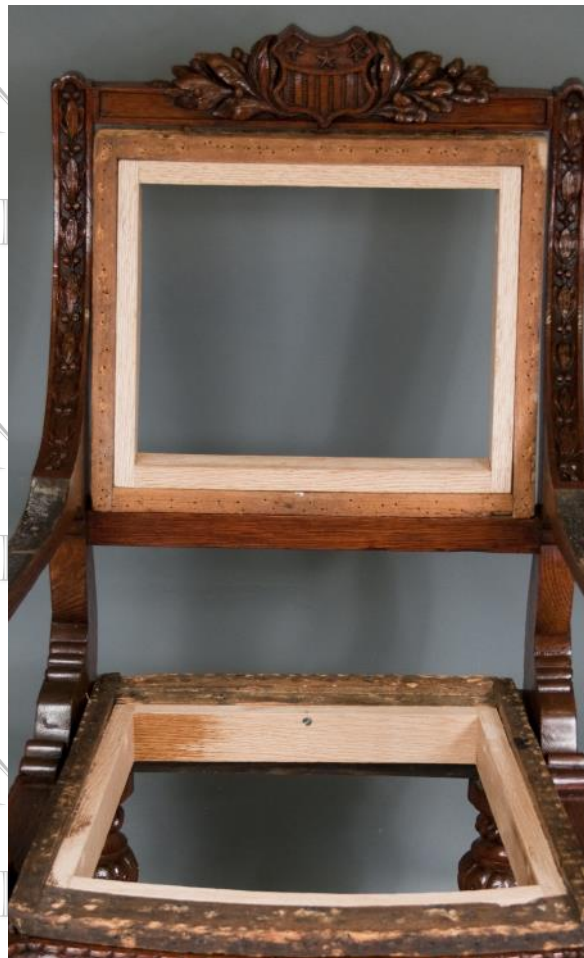
The nailed soft-wood box was added in the 4th quarter of the 19th century when springs were applied to the seat to create a cavity in which the springs would reside. At least two separate upholstery regimes were undertaken using this applied box system.

For this treatment, the existing oak frame was retained, and the 1860-1890 poplar addition was removed. A new oak inner frame was fabricated (for both the seat and the back). This new oak strip was used as a rail to adhere the traditional upholstery materials in a minimally intrusive manner.

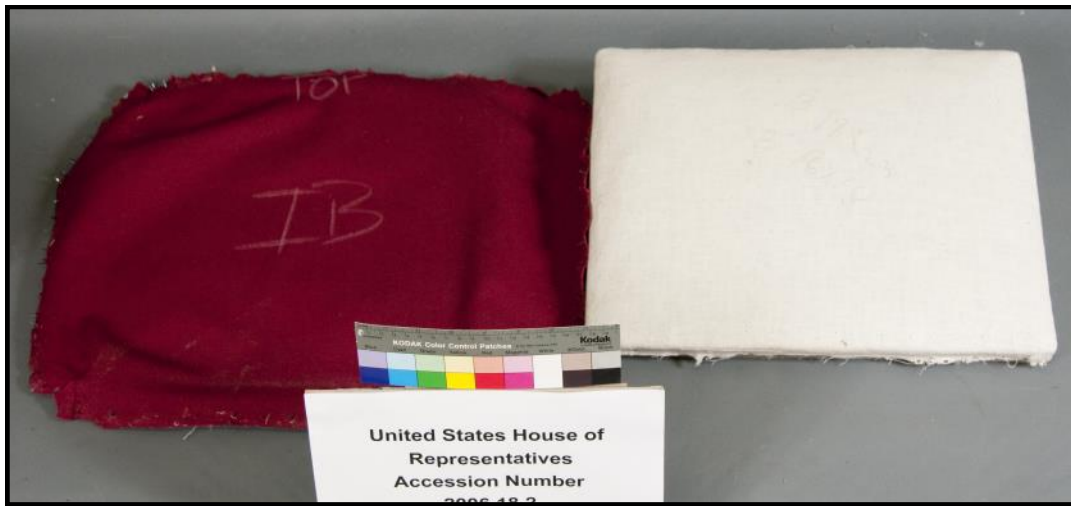
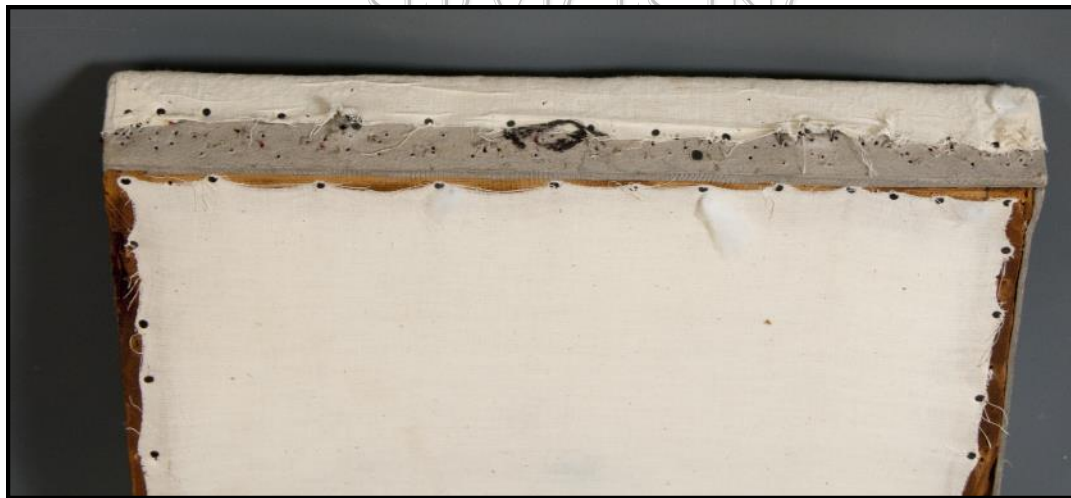
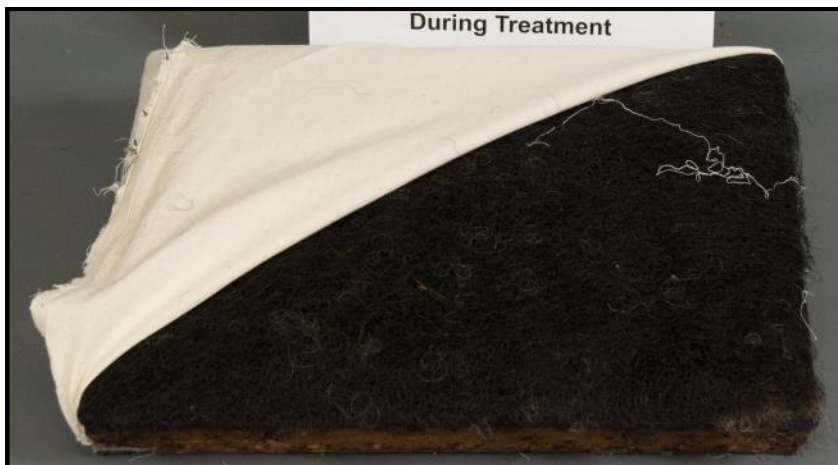
These images depict the existing layers of upholstery on the back seat frame, including the show cover (top), a muslin under layer (middle) and a hog/horsehair layer (bottom).

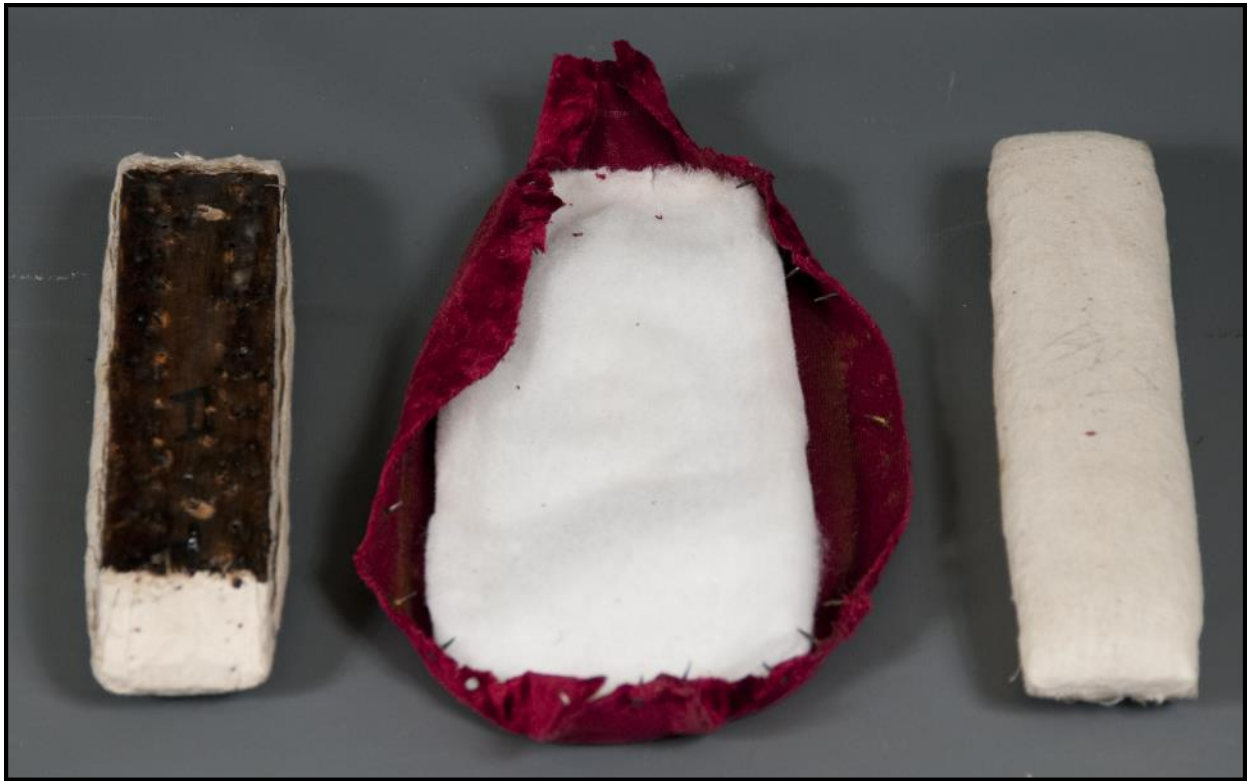
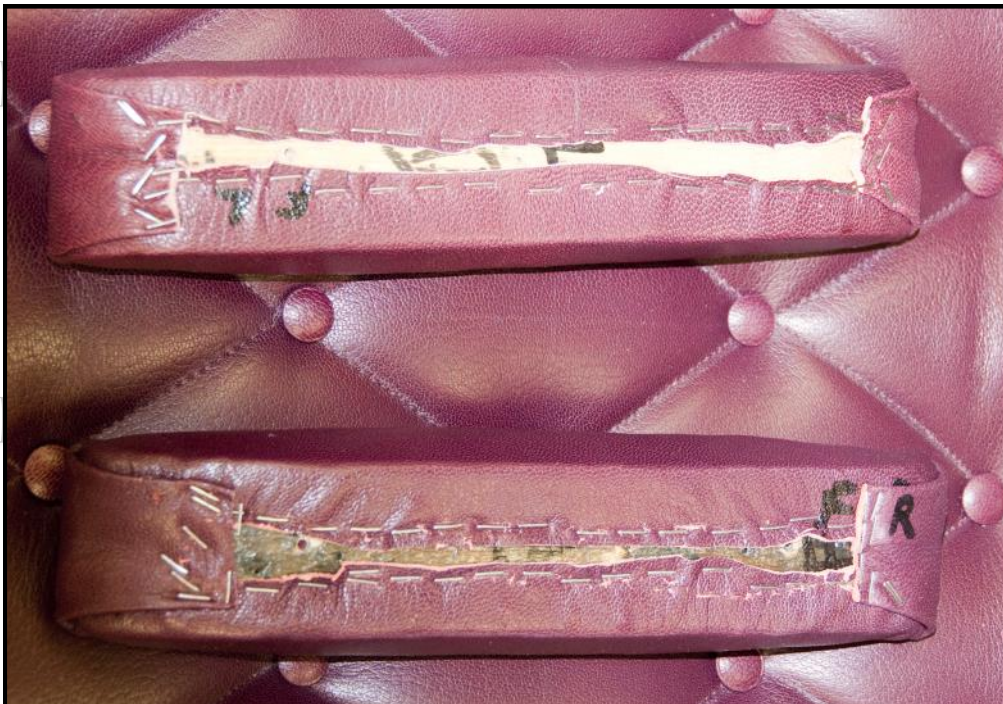
These images depict the various layers of existing upholstery on the arm sections.

The show cover was removed from the arms, but all of the existing under upholstery

materials were retained and additional horse hair was added. The arms were covered with the same

also retained and additional hair cotton was added. The arms were covered with Moroccan goat
