**CONDITION AND TREATMENT REPORT**

**DATE:** September 19, 2012

**OBJECT:** One of a group of two donated American custom designed and manufactured armchairs for the Hall of the House of Representatives, currently in the collection of the United States House of Representatives, known as the "Walter" armchairs, after their designer, Thomas U. Walter. The primary wood is American oak; the secondary wood is oak, manufactured by Bembe and Kimbel of New York, circa 1857.

**ACCESSION #:** 331833 (old); 2006.18.2 (new).

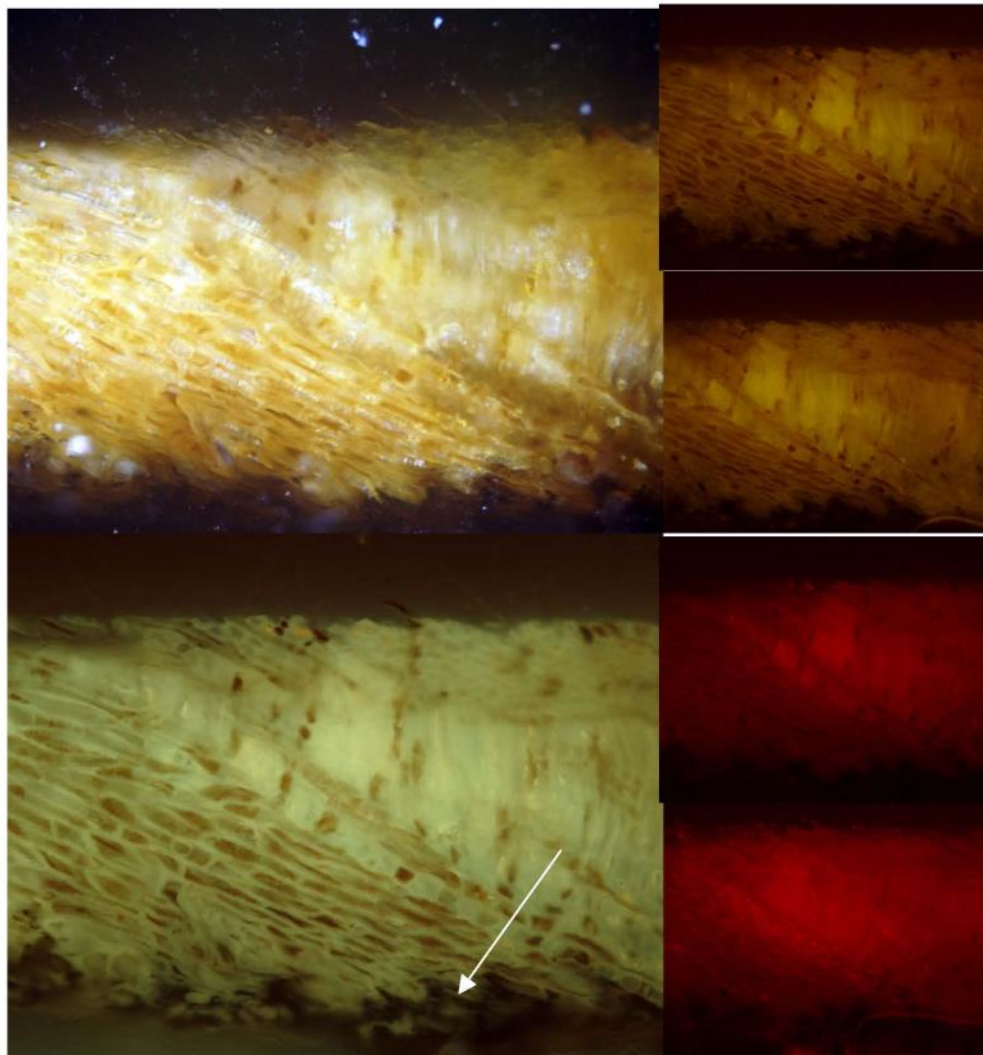
Top Left View: Normal Light. Bottom Left View: Violet Excitation. Top Right View: Blue excitation only. Top Middle Right: Blue excitation, stained with Alexafluor 488 succinimide in a pH 9.0 Borate buffer (chartreuse fluorescence=positive for proteins). Bottom Middle Right: Green Excitation only. Bottom Right View: Green excitation, stained with Rhodamine B in ethanol (red-orange fluorescence = positive for drying oils).

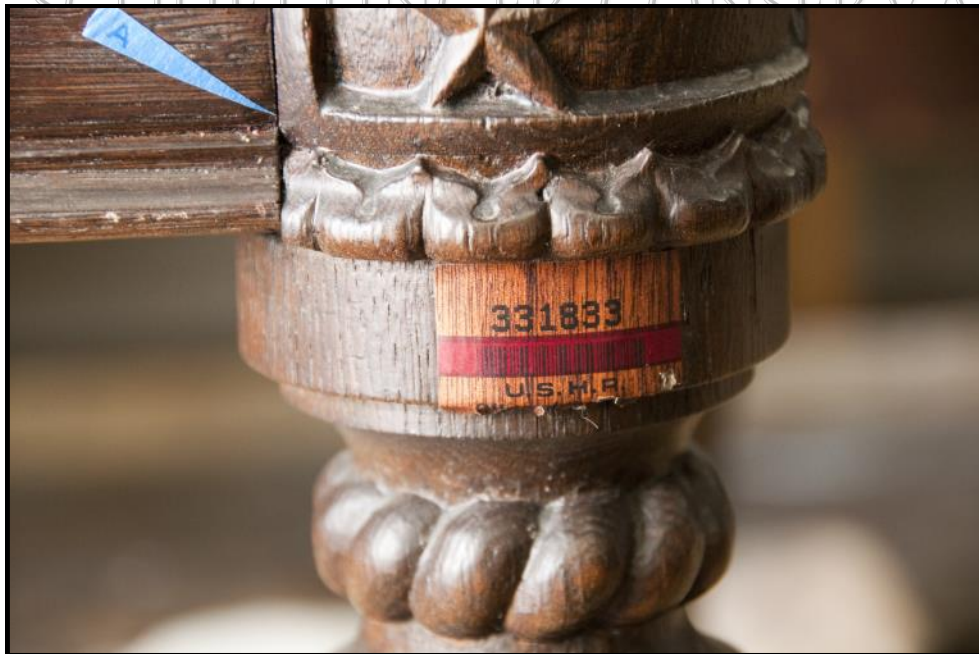
Sample A appears to have lost its coating materials per se, but there is evidence (here at the bottom of the mounted sample, white arrow) of the initial oil/carbon black stain found in the samples taken from the second chair, accession #331834.

Both chairs #331833 and #331834 (treated in 2011 by SCS) were stripped of their original coatings when they were dipped in a lye based solution before the existing coatings were applied. According to Wolbers, it was an oil type of stain that saturated the wood surface, and likely left the black/carbon residue in the wood pores. There was also an initial natural oleoresin clear coating. At least three subsequent coatings appear to have been applied over the original coating/staining materials; an oil coating; an oleo-resinous clear coating; and an additional oleo-resinous clear coating.
