**CONDITION AND TREATMENT REPORT**

**DATE:** September 19, 2012

**OBJECT:** One of a group of two donated American custom designed and manufactured armchairs for the Hall of the House of Representatives, currently in the collection of the United States House of Representatives, known as the "Walter" armchairs, after their designer, Thomas U. Walter. The primary wood is American oak; the secondary wood is oak, manufactured by Bembe and Kimbel of New York, circa 1857.

**ACCESSION #:** 331833 (old); 2006.18.2 (new).

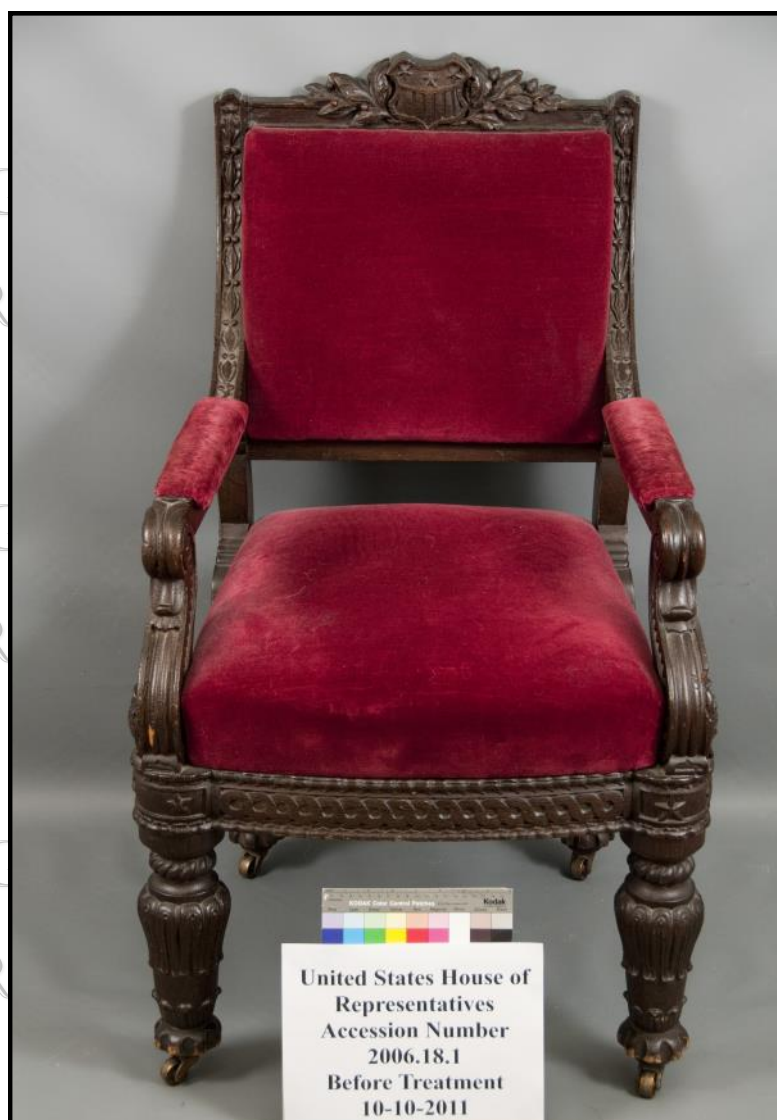
Left: United States House of Representatives Thomas U. Walter Armchair, circa 1857, before treatment.

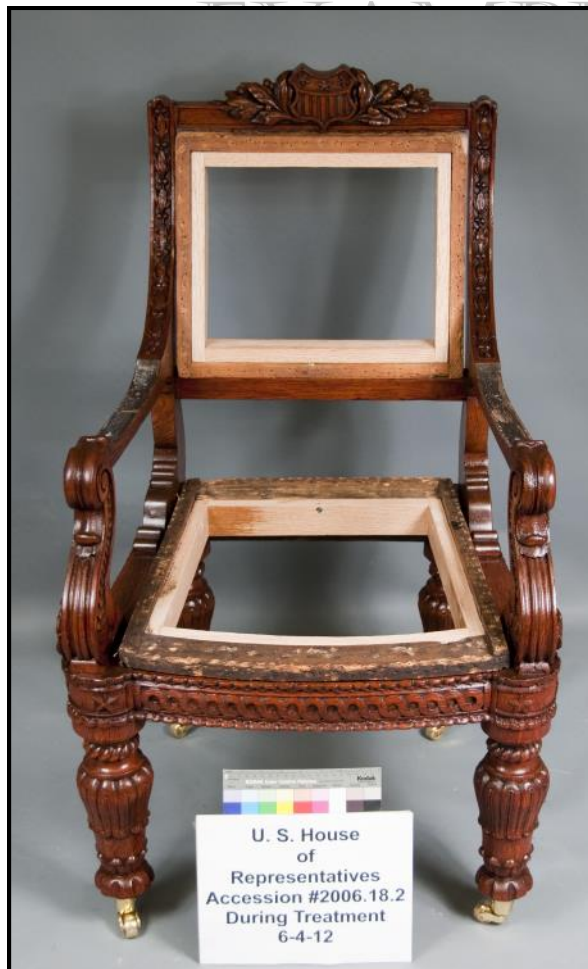
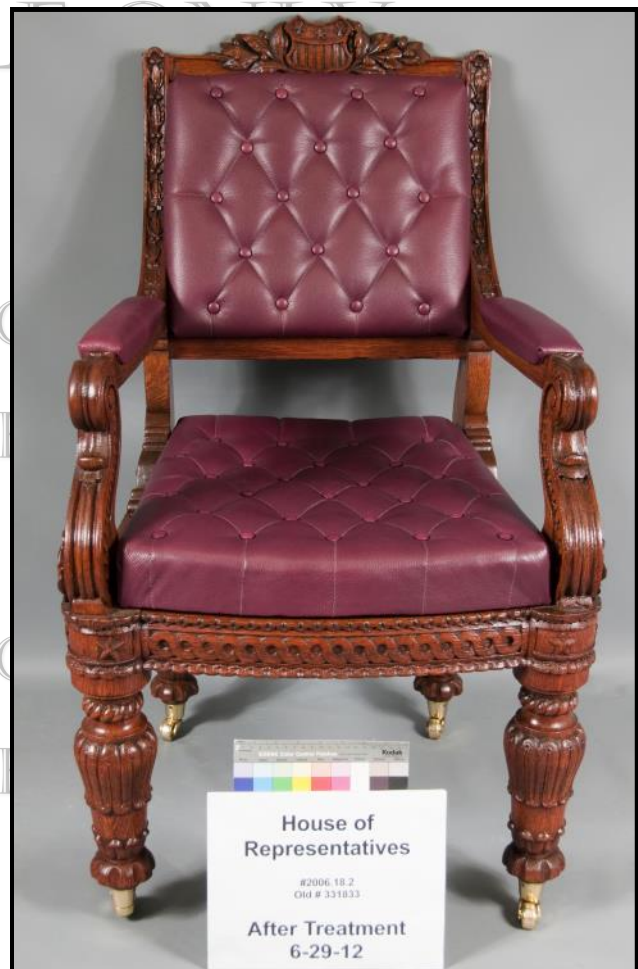
Left: Chair during treatment, after the structural and coating treatments have been completed.

Right: Chair after treatment with structural, coating and upholstery treatments completed.

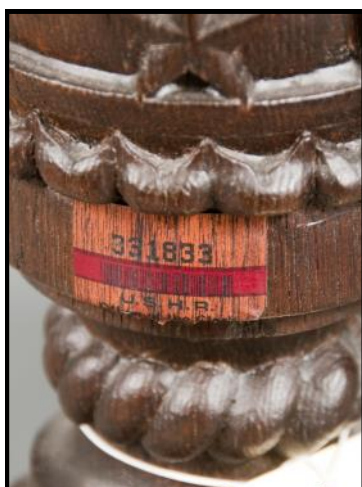
Labels/Writings: Cellophane label affixed to back of chair with accession number printed on it "331833" (below left).

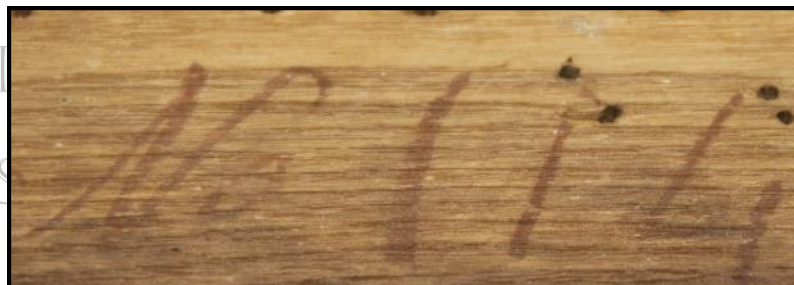
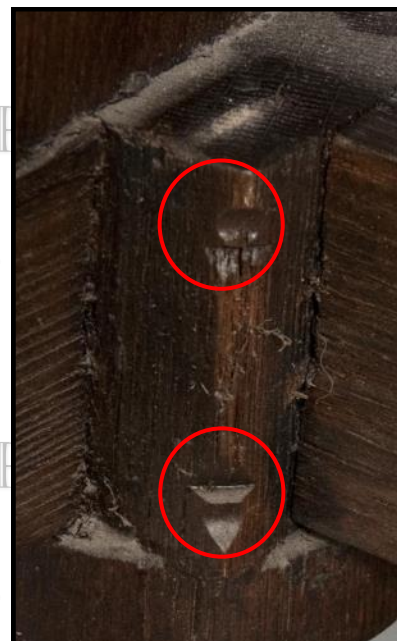
Unusual Construction Techniques: A distinctive notched corner block was used in the seat frame of this chair, a signature of an individual cabinetmaker (right).

On the back frame, under the upholstery, there is a period ink inscription, "No 114" (below right), probably either production number or seat position within the hall.

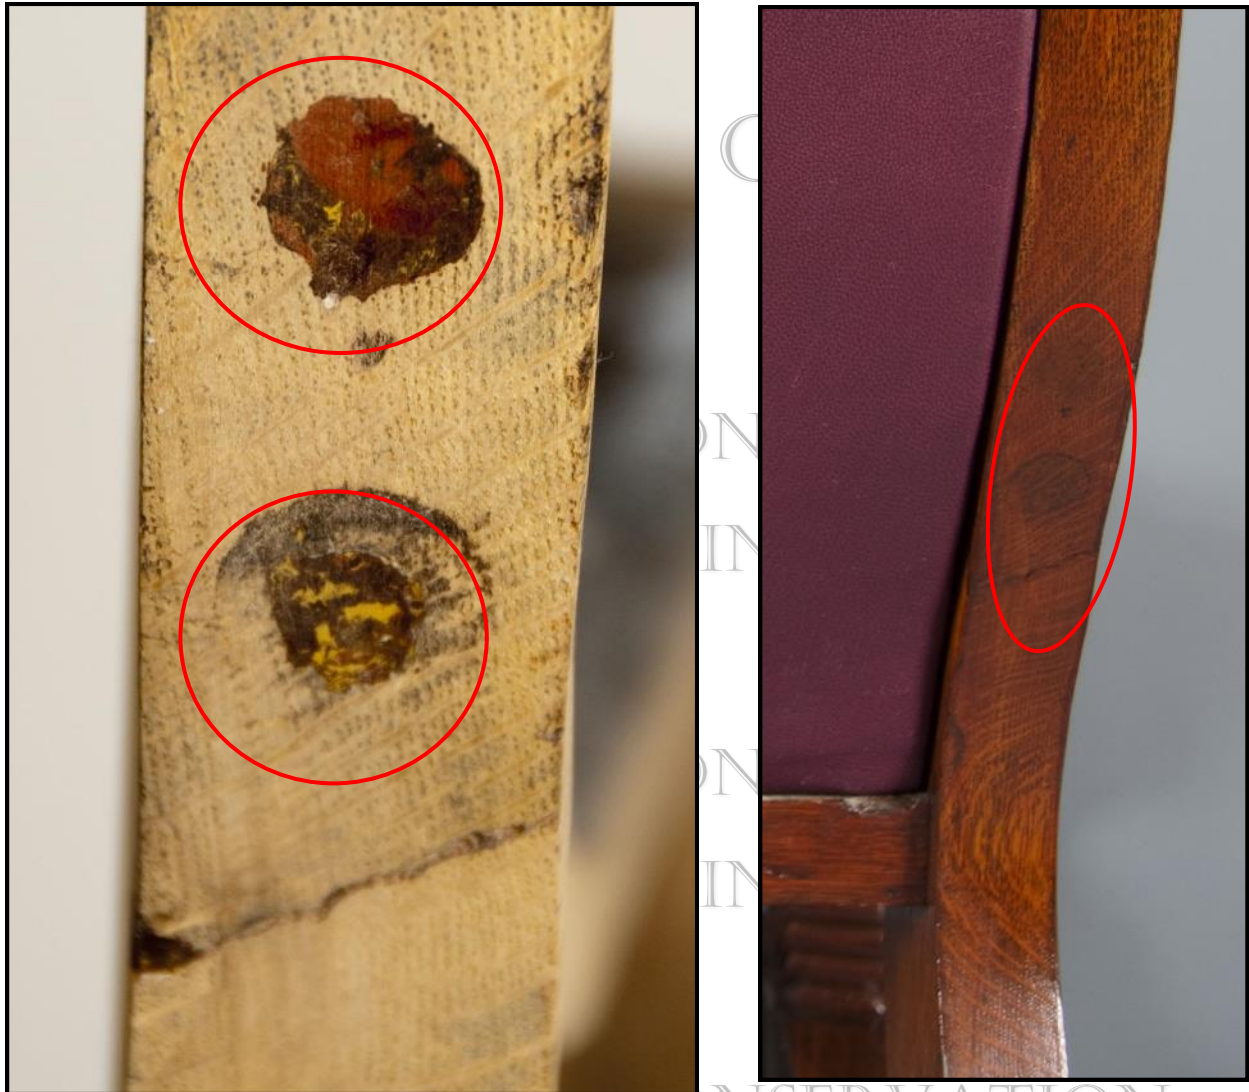
There was a major fracture on the proper left stile of the chair. Previous attempts had been made to secure the fracture, using dowels and glue, but these attempts failed to make the chair structurally sound. The old adhesive and dowels were removed and the dowels discarded.

These images, left and right show the stile before treatment, illustrating the previous attempts at repair. Below left and right show the fractured stile cleaned of the old adhesive and the dowels removed, in preparation for treatment.

To consolidate the previous fracture, Araldite 2015 structural epoxy was used to adhere the fracture, a barrier layer was not used because of the required strength of the joint. A new hard wood dowel was used to fill the holes left from the previous repair regime and was secured with fish glue. Acryloid B-72 20% in toluene was used as a barrier and the area was infilled with Acryloid B-72 color chips applied via a heat system. These areas were incoated with de-waxed blond shellac as a binder, Oresol dyes and ground natural pigments as colorants in a denatured alcohol and de-waxed blonds shellac as the vehicle. Approximately 6 layers were required to achieve the level depicted in the image above right. (see p. 25 for a full coatings treatment).

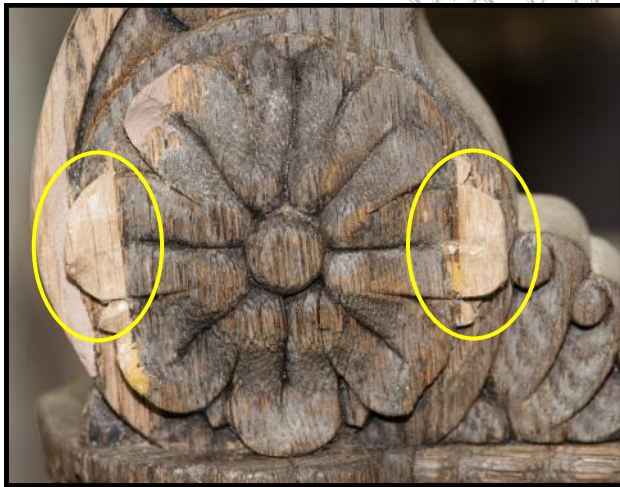
This image illustrates the area of the proper left arm rail where it meets the seat, before treatment. There were areas of wood loss to both sides of the carved floral element

New elements of wood of like kind and quality were fabricated and shaped to fit the existing areas of loss and secured with Araldite 2015 structural epoxy and a fish glue barrier.

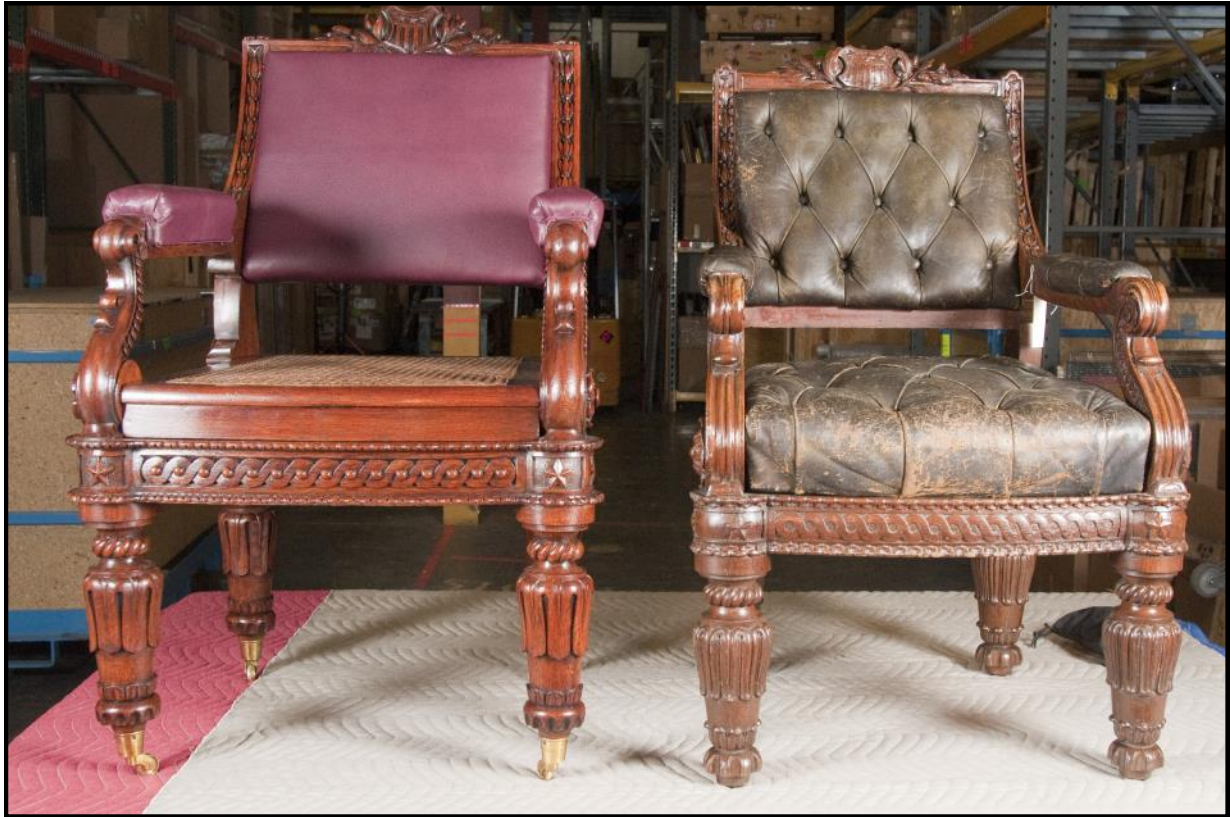
This chair on the left was manufactured by the Desk Manufacturing Company with the caned, or summer seat., which our firm treated in 2011. The upholstery system for this chair was determined based on the physical evidence found in the original under upholstery materials existing with the chair and the upholstery system developed by Michael Mascelli in 2005 as well as the historical evidence present in his condition and treatment report.

The chair on the right was manufactured by Bembe and Kimbel, and may have the original undisturbed coating history and a second generation of upholstery that most closely resembles the button and pleat upholstery pattern shown on Walter's design drawings. Upholstery conservator Frank Kalista examined this chair at the Artex Storage facility. Because of the nature of the webbing, coil springs and interior coverings and filling materials, he determined that the existing button and tufted upholstery treatment appears to be like those manufactured around 1930. He also noted that there were very few holes in the seat frame, so that the chair had likely not been reupholstered more than the one time in the 1930s.

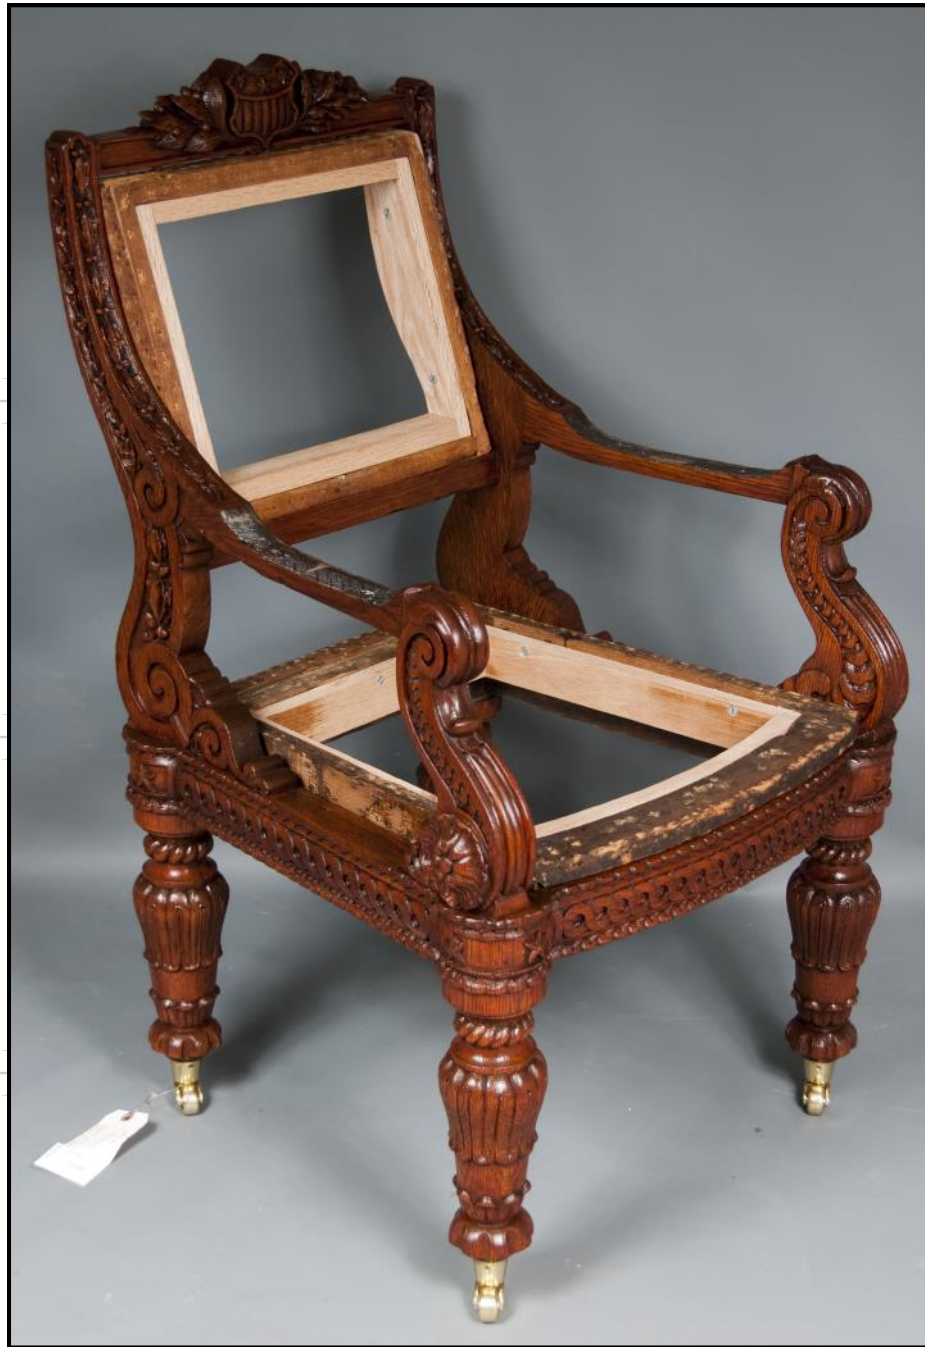
This image depicts the chair with the structural and coating treatments completed, and newly constructed seat and back frames adhered in preparation for new upholstery.
